TECHNICAL NOTE 2039

INVESTIGATION OF FRETTING CORROSION

BY MICROSCOPIC OBSERVATION

By Douglas Godfrey

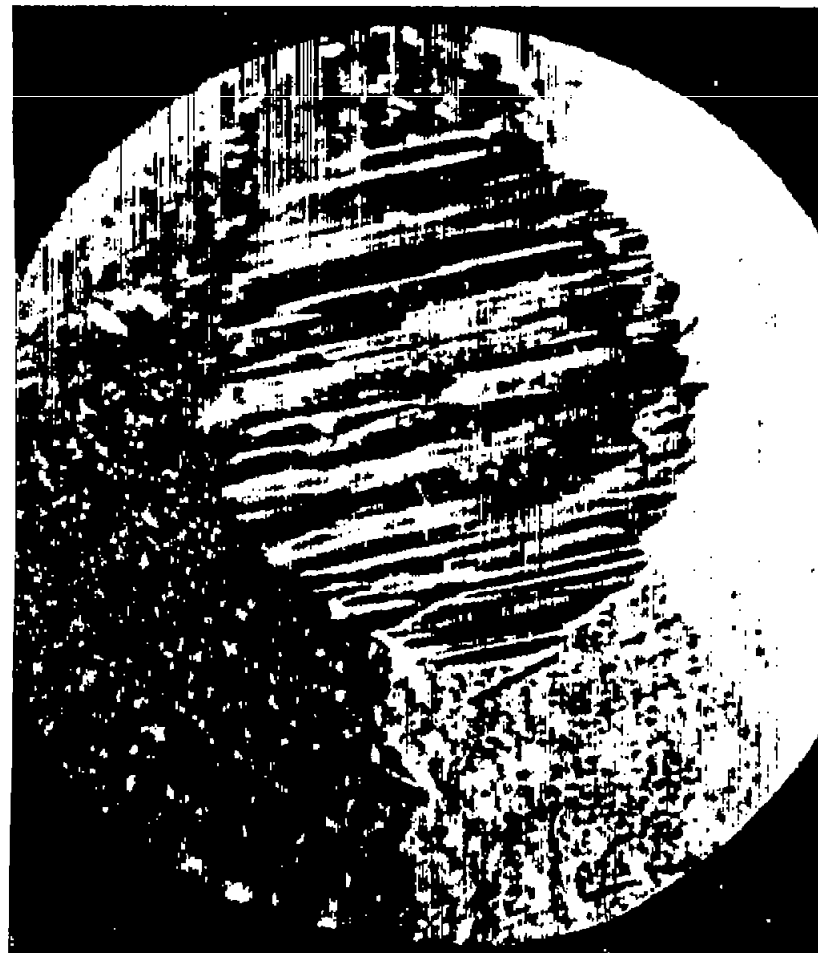
(a) Before cleaning.

(b) After cleaning.

Figure 4. - Photomicrographs showing fretting-corrosion area on chrome-alloy steel ball after 1800 cycles. X140.

After approximately 20,000 cycles, the action stabilized to a steady-growth condition with continued generation of material in the black spots surrounded by brown semifluid oxide and the formation of fine powder-like oxide. The black color of the active areas indicated the presence of finely divided iron; this indication was further confirmed by subsequent change to dark brown and then to rust brown. If the vibration was stopped, the trapped black material could be seen to gradually turn brown. Finely divided iron, ferrous oxide  $\text{FeO}$ , and ferrosferric oxide  $\text{Fe}_3\text{O}_4$  are black; whereas, ferric oxide  $\text{Fe}_2\text{O}_3$  and its hydrated form  $\text{Fe}_2\text{O}_3 \cdot \text{H}_2\text{O}$  are reddish. Because the fretting-corrosion debris of steel was identified by electron diffraction as  $\text{Fe}_2\text{O}_3 \cdot \text{H}_2\text{O}$ , the color changes that occurred show the progressive oxidation of the iron. Fretting corrosion is apparently initiated by the loosening, due to inherent adhesive forces, of extremely finely divided and apparently virgin material that is extruded and reacts with oxygen simultaneously. Examination of the ball after the experiment revealed a flat oxide-encrusted spot (fig. 4(a)), which on subsequent cleaning was revealed to be a clean abraded flat spot (fig. 4(b)). The sticky oxide on the glass was removed with difficulty but completely with acids and a striated, cracked area was revealed. The striations could not be brought into sharp focus with the microscope, indicating appreciable depth and irregularity (fig. 5(a)). If the action was continued for longer periods, the glass fragmented locally (fig. 5(b)) and was pitted.

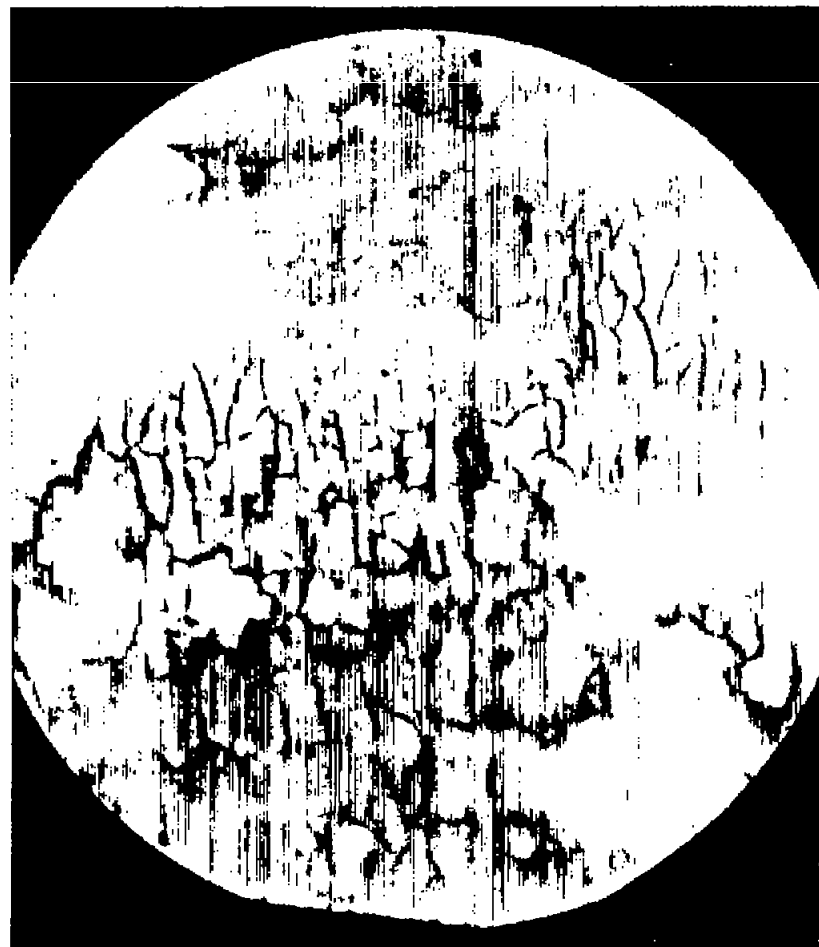
(a) Early stage, X140.

(b) Later stage, X300.

Figure 5. - Photomicrographs of cleaned wear area on glass showing cracking and striations produced by vibration of contacting chrome-alloy steel ball.

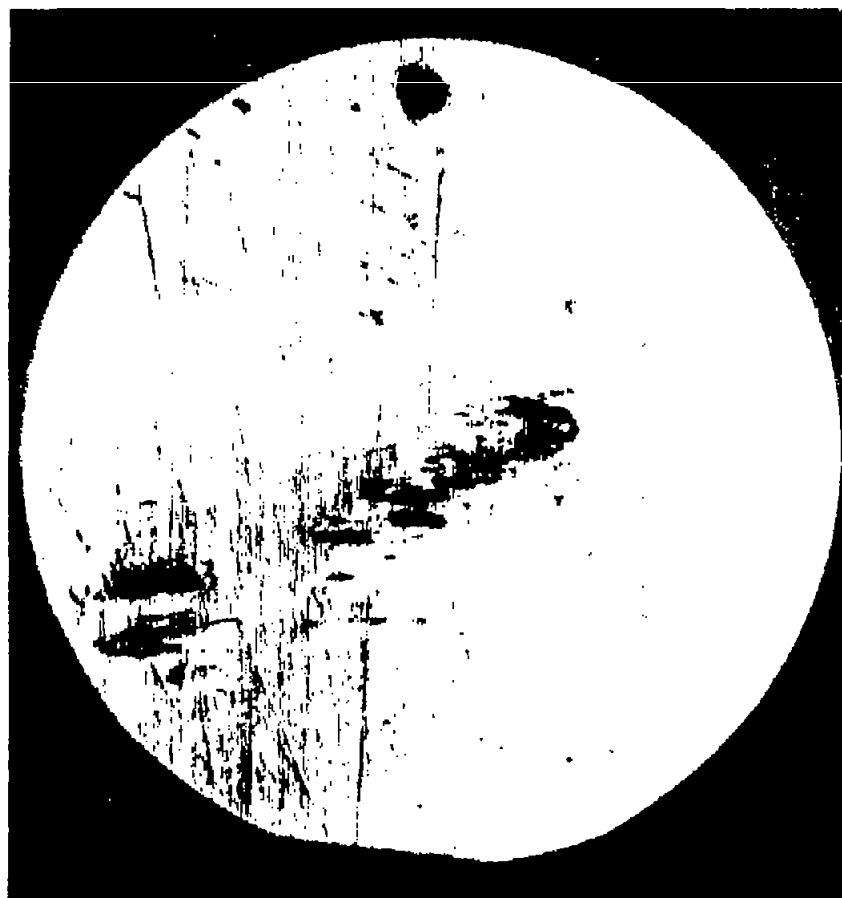
(a) Early stage.

(b) Advanced stage.

Figure 6. - Photomicrographs of convex platinum surface through glass slide showing wear and debris produced. X140.

(c) Debris accumulation outside field of view of figure 6(b).

Other metals vibrated against glass slides supported the explanation of fretting corrosion deduced from the steel-glass experiments. In one experiment, flame-cleaned platinum foil supported by a steel ball was vibrated in contact with clean glass. The generation of a black powder in the characteristic way was observed (fig. 6). This powder remained black and that which

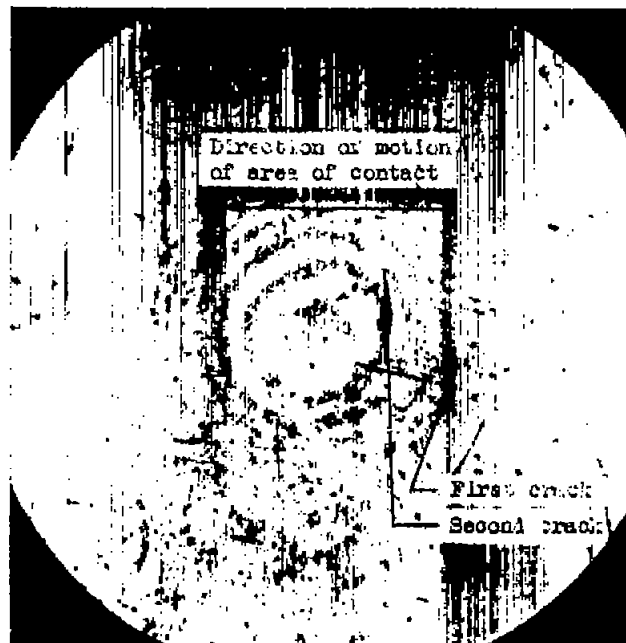
(b) View of ball through glass showing second crack being formed in glass on trailing edge of area of contact.

(c) View of glass slide showing resultant row of cracks.

Figure 7. - Photomicrographs showing effects of one-half cycle vibration between glass and steel surface. X140.

Under the conditions of the 1/2-cycle experiment two types of action were observed. If the surface of the ball was previously roughened with 2/0 emery paper, the glass would polish the contact area on the ball and become smeared with the semi-fluid oxide, which would again tenaciously adhere to the glass. The amount of debris accumulated in three 1/2 cycles of vibration is shown in figure 7(a).
